All models

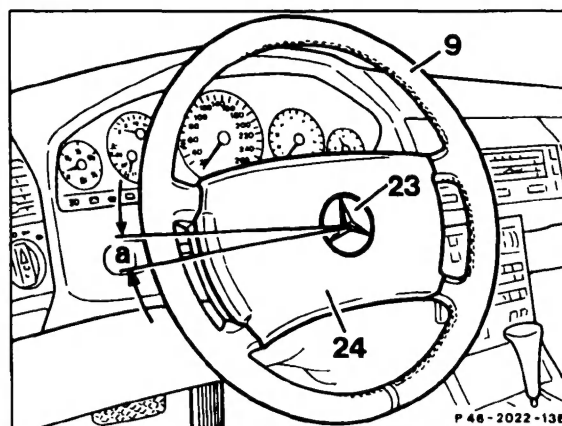
- In steering center position, maximum allowable play (a) at steering wheel is 25 mm.

a = max. 25 mm

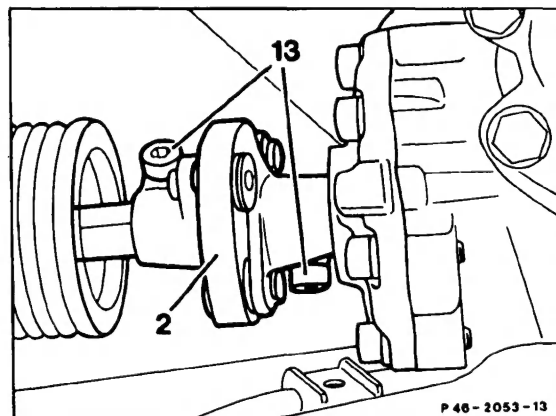
Models 124 (except 124.034/036), 129, 201

- On all models starting 04/1984, check play of steering coupling or of both flexible couplings (2).

2 Flexible coupling

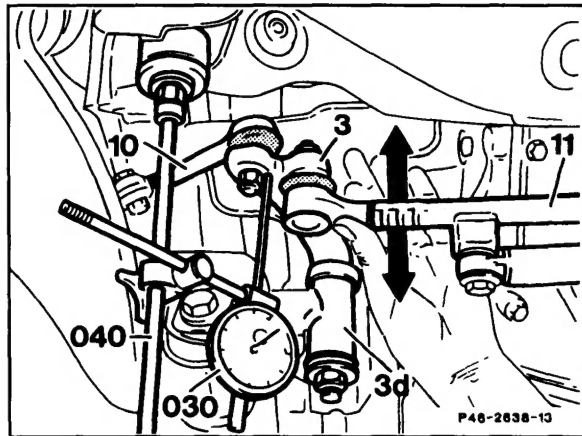
All models except 140

- Check mounting of idler arm (3) in rubber bushings, using dial indicator as necessary (SMS Job No. 46-0110). If play is greater than 0.5 mm, replace rubber bushing (SMS Job No. 46-0520) on separate order.

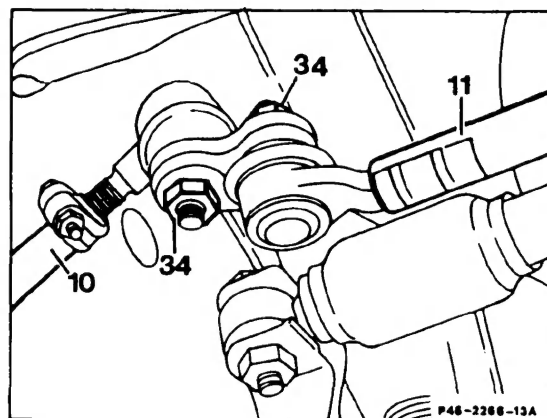
- With vehicle resting on wheels, move steering left and right approx. 100 mm while checking the following ball joints:
- Tie rod end (10) ball joints.
- Tie rod (11) ball joints.
- If play is found, replace the appropriate ball joint.
- Check condition of rubber boots.

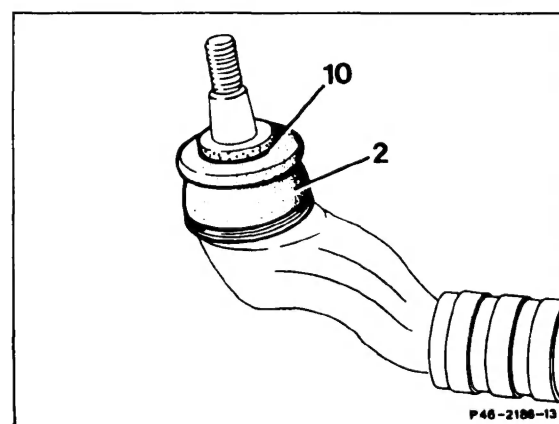
If a damaged rubber or plastic boot is found, replace affected joint immediately, since penetrating dirt will destroy joint in a short time. **Replacement of only the boot is permitted only if no dirt whatsoever has entered the joint.**

2 Rubber boot
